## SITE INSPECTION AND REPORT

Roof type:

Nature of works:

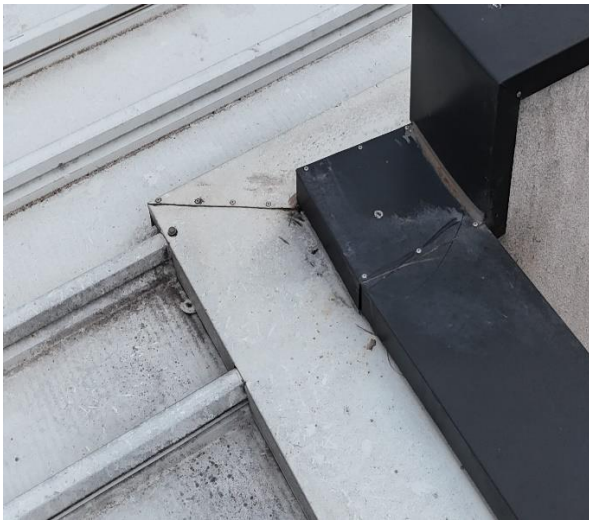
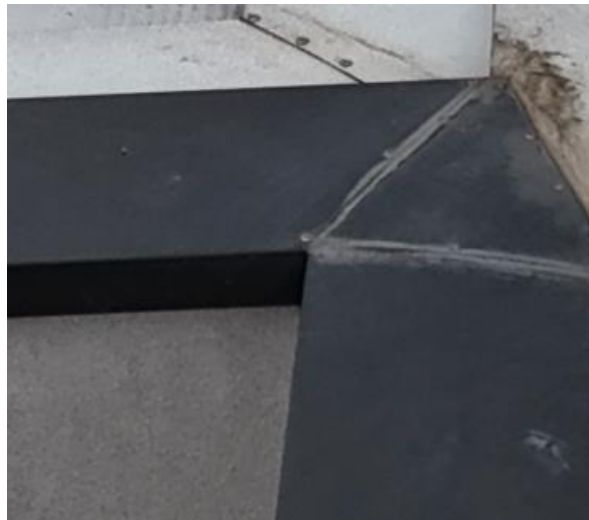
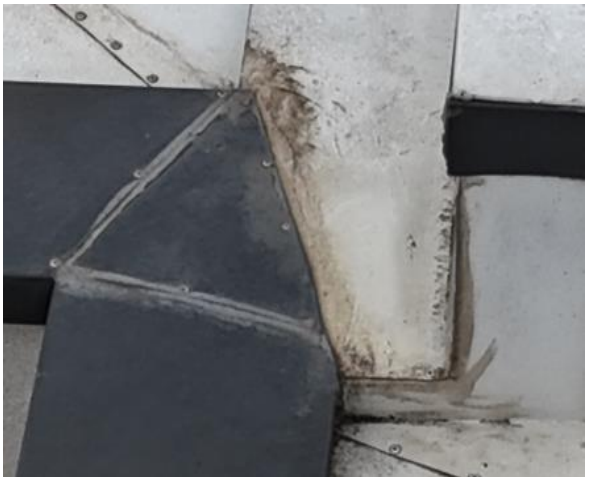
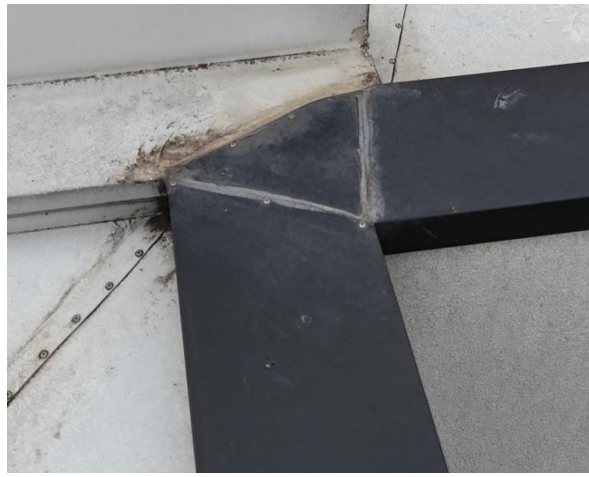
1.

**NCC 7.2.7 & AS 3500.3 part 4.7.2.2:- Sealant joints shall be used in conjunction with mechanical connections or fasteners, and spaced at not more than 40 mm centres. Flashings and capping connections do not meet these requirements.**

(d) Joints in *flashings* and cappings must be not less than 75 mm, lapped in the direction of the fall of the roof, and fastened at intervals not more than 40 mm.

Sealant joints shall be used in conjunction with mechanical connections or fasteners as specified in AS/NZS 2179.1, and spaced at not more than 40 mm centres. The sealant shall be sandwiched between clean surfaces of the components of the joint to ensure a positive seal and to protect the sealant from exposure to ultraviolet radiation.

All areas to comply  
2.

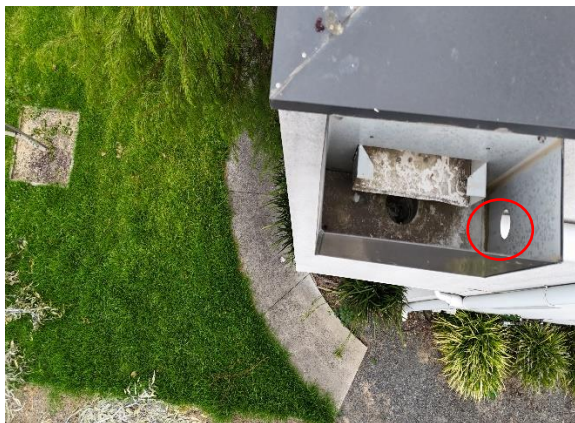
SA HB 39;5.3.1, 3500.3; Figure 3.8: - Over flow size to rainhead are to be calculated in accordance with AS 3500.3.

- (a) The size of overflows are to be calculated in accordance with AS/NZS 3500.3.
- (b) Overflows are to be terminated in such a way as to prevent damage to buildings and property.
- (c) The hydraulic capacity of overflow devices are to be not less than the design flow for the associated gutter outlets and discharge to atmosphere.

Builder to clarify calculations.

Ensure rainhead overflow size asd per AS 3500.3

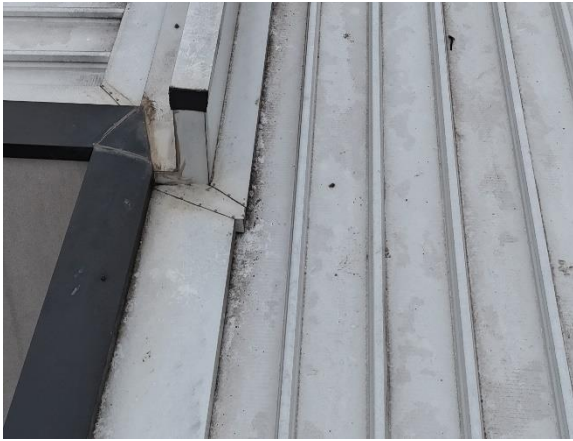
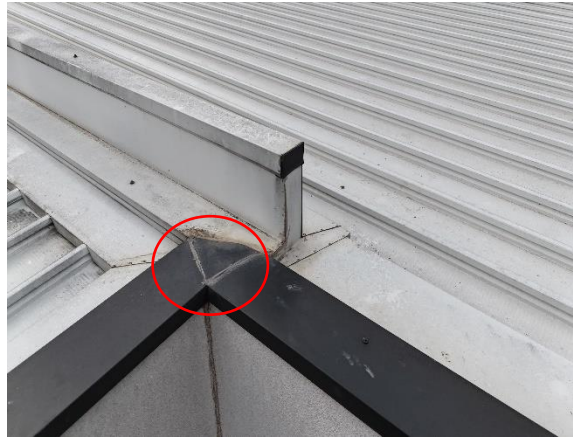
**3.**

**AS 3500.3; 4.4.3:** - Metal roof drainage systems and support systems shall be designed to achieve complete drainage or drying and ensure no premature corrosion.

The current installation has not met these requirements.

Metal roof drainage systems and support systems shall be designed and installed to achieve complete drainage or drying. Shielded areas capable of causing permanent ponding shall be avoided to prevent the possibility of intense localized corrosion known as crevice corrosion.

NOTE: This type of attack results from contact of metal with moisture and salts under oxygen-deficient conditions in which trapped moisture cannot readily evaporate. It can be caused by lap joints, absorbent gaskets, holes, crevices under bolt or rivet heads, or surface deposits, including non-metallic materials such as elastomeric materials, plastics, fabrics, lifted paint films or accumulated solids.

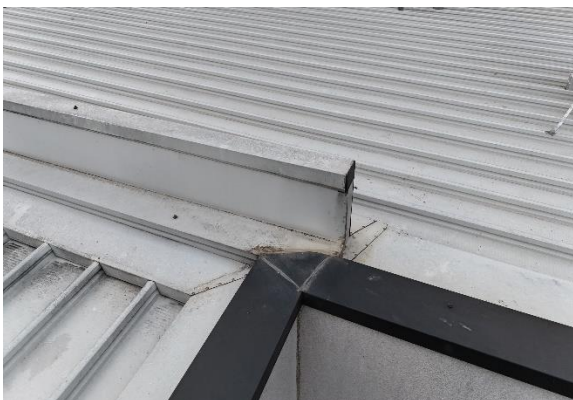
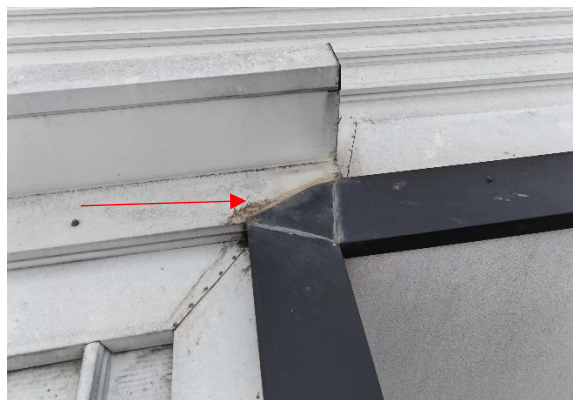
4.

**SA HB 39;5.8.1:** Soldering or silicone sealed joints are to be flush and lapped 25mm in the direction of the fall.

Dwelling does not meet these requirements.

Soldered or silicone-sealed joints are to be flush and lapped 25 mm in the direction of the fall, with one row of rivets or other approved type fastenings at spacings not exceeding 40 mm. This applies to all joints in flashings, cappings, eaves, gutters, box gutters, soakers, penetrations and all general sheet metal joints in roof plumbing.

Direction of fall

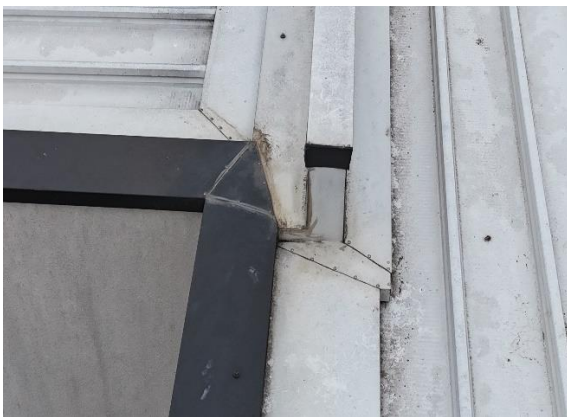
**The Domestic Building Contracts Act 1995; Implied Warranties, sect. 8(a):** - The building contractor warrants that work will be carried out in accordance with the plans and specifications set out in the contract.

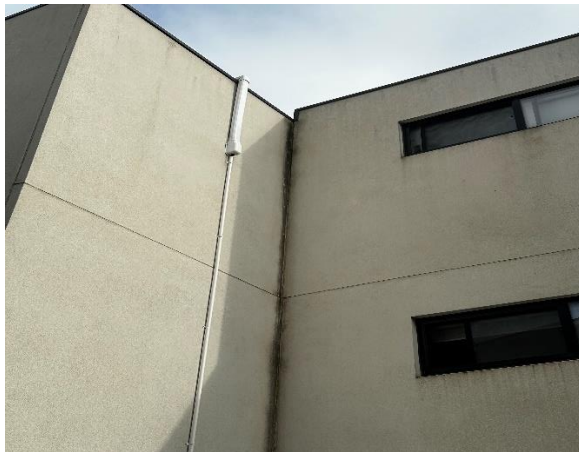
5.

**SA HB39; 8.7(b):** - Parapet flashings shall fall back towards the roof coverings so as to prevent water from dripping down the flashing causing unsightly staining. Minimum fall 3 degrees.

The parapet flashings have not met this requirement.

- (a) *Thermal movement* Where thermal movement is likely to be a problem, cappings fixed to metal roof covers to be fastened with cleats or sliding supports to all other surfaces.
- (b) *Parapet cappings* Parapet cappings to be fixed to parapet walls at intervals not exceeding 500 mm with masonry anchors and cleats that permit longitudinal expansion and contraction. A minimum fall of 3° to be provided across the width of the flashing, to divert water back onto the roof coverings so as to prevent the water from dripping down the fascia causing unsightly staining [see Figure 8.7(A)].

Garage

All areas to comply.

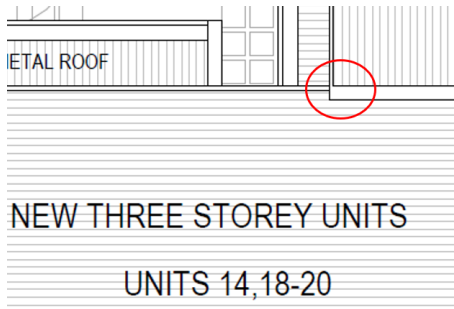
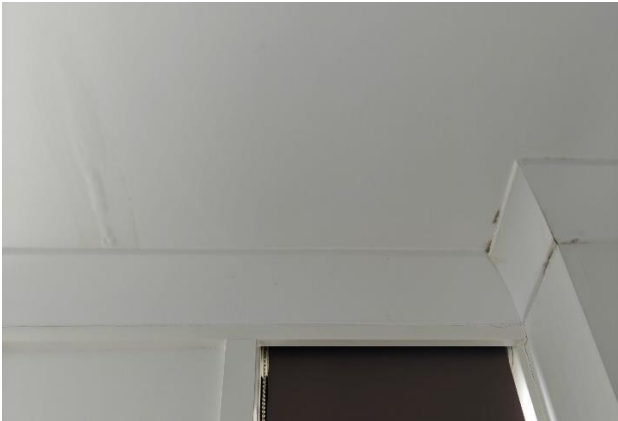
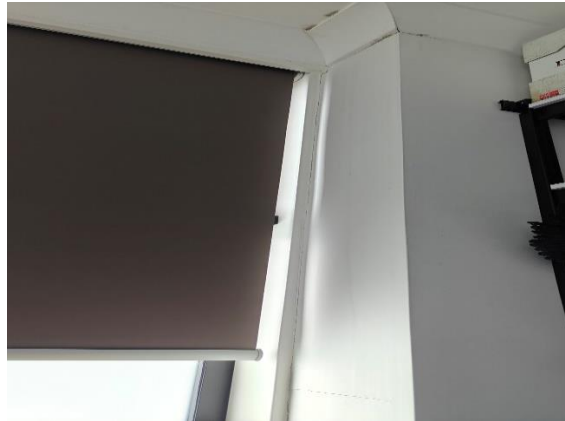
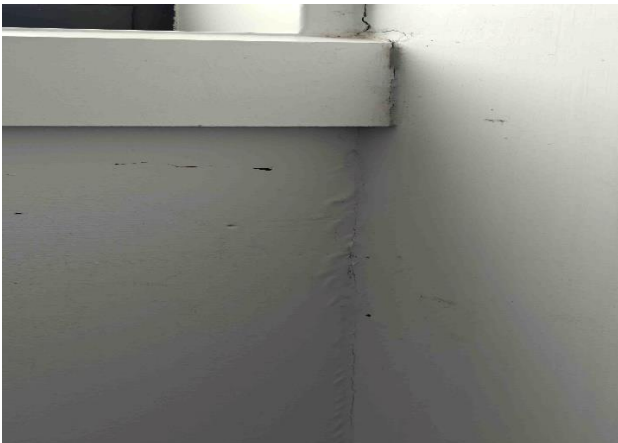
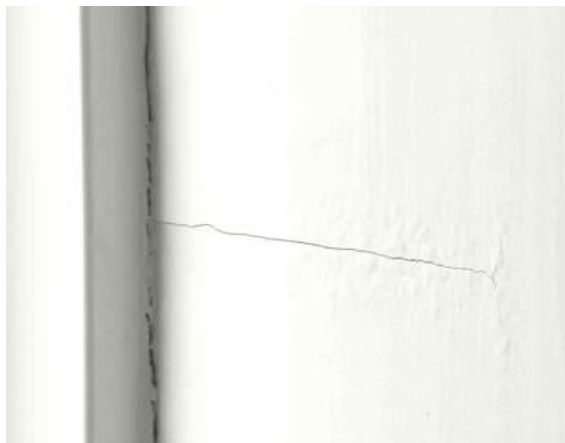
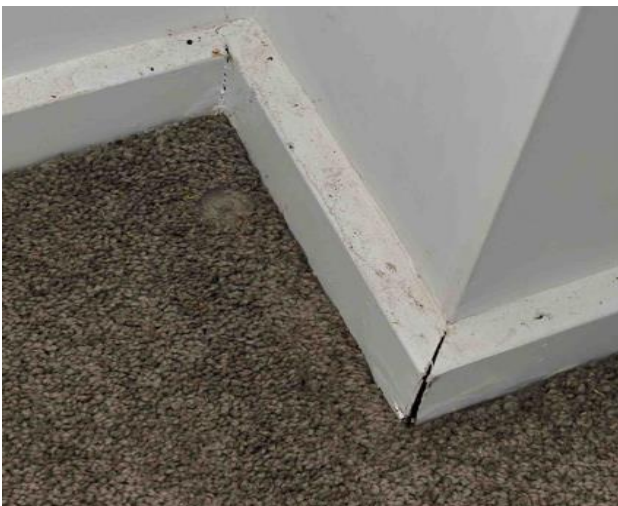
### 6.

**NCC 2019; P2.2.2; AS 2589 section 4; AS 3999; G2:** -It was noted that the dwelling was not watertight. A roof and external wall including openings around windows and doors must prevent the penetration of water that could cause unhealthy or dangerous conditions and undue dampness or deterioration of building elements.

The dwelling does not meet these requirements.

**Note:** Water ingress has been detected in Bedroom 2 of the dwelling. Defects 1, 3 and 4 are found directly above this area of concern.

Photos provided by client

# Rectification Required: YES
